FIRST FLOOR PLAN

ADDITIONAL NOTES

EXISTING CONDITIONS

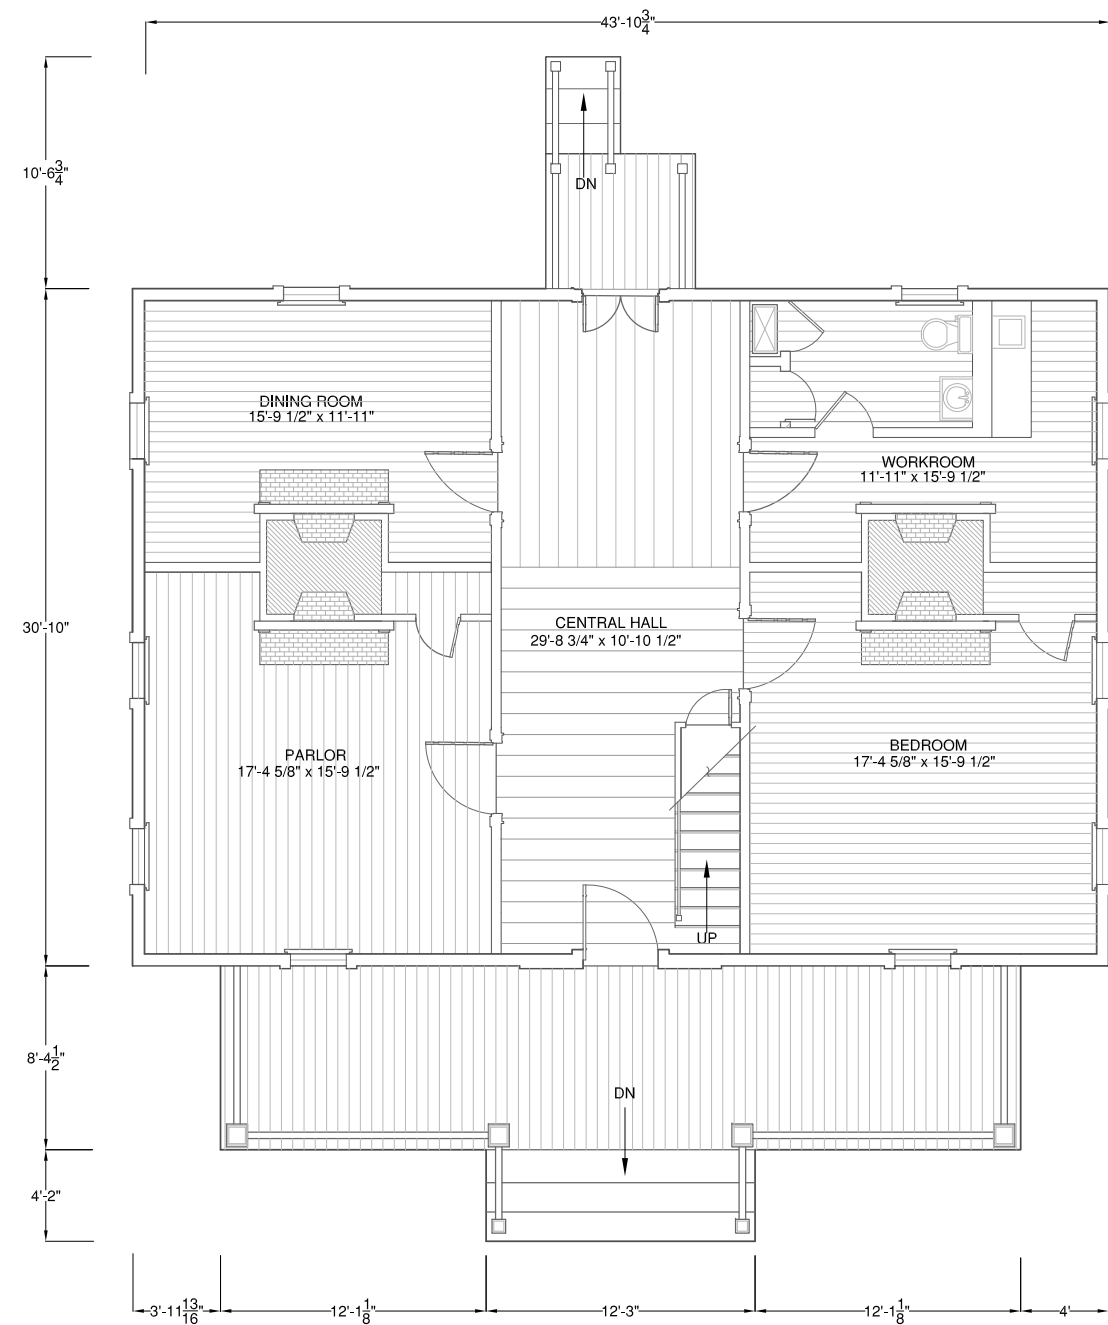
- * EXTERIOR AND FIRST FLOOR HAVE UNDERGONE RESTORATION AND ARE IN EXCELLENT CONDITIONS.
- * THE SECOND FLOOR SHOWS SIGNS OF SIGNIFICANT DETERIORATION OF FLOORBOARDS AND WALLS
- * SOME EVIDENCE OF RESTORATION EFFORTS OF FLOORBOARDS, WALLS, AND MATELS ON SECOND FLOOR.

- * REAR LEFT BEDROOM RENOVATED TO A WORKROOM AND BATHROOM
- * DURING RESTORATION, OPEN ACCESS BETWEEN PARLOR AND DINING ROOM CLOSED OFF
- * EXTERIOR ASBESTOS SIDING REMOVED TO EXPOSE ORIGINAL WEATHERBOARD
- * SHED ADDITION ON NORTH FACADE REMOVED DURING RESTORATION
- * SOME EXTERIOR WINDOWS RESTORED TO MATCH ORIGINALS
- * REPLACEMENT FRONT PORCH
